Gunite Troubles

This featured project highlights the effects of poor-quality gunite, particularly when it meets expansive soil.

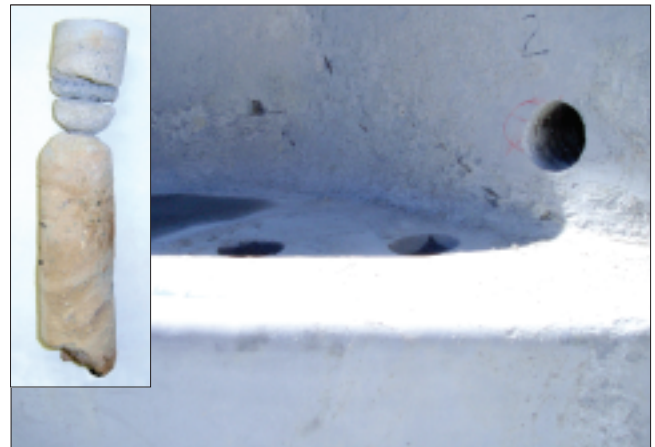
The pool was built in an area with expansive clays, which wreaked havoc on other nearby pools and patio flatwork. Initially, we suspected that ground conditions had caused the damage. However, careful inspection of the pool cracks led us to another conclusion. Jagged, disjointed cracks that do not intersect the bond beam often are the telltale sign of poor gunite workmanship.

To confirm our suspicions, we collected eight core specimens from three locations throughout the pool: the walls, benches and steps. The samples were porous and had several layers of uncompacted sand, called lenses. This usually results from shoddy nozzling.

Five of the eight cores were classified as a grade of 5. The three remaining were rated a grade of 3. The average

grade of the eight cores was 4.25. ACI considers an average grade above 2.5 to be unacceptable.

Poor workmanship: Cores taken from the pool (above) revealed poorly applied, weak concrete. Of the eight cores taken throughout the pool, five indicated shoddy nozzling during the gunite process. The cracks were repaired with epoxy injection (right), after which a layer of fiberglass was applied over the vessel's interior.

The project specifications required a minimum compressive strength of 2,500 psi. Compression test results varied from 810 to 3,130 psi, with eight of the 12 tests below 2,500 psi. An expected unit weight for high-quality gunite should be on the order of 135 pounds per cubic

foot. Unit weights ranged from 113 to 133 pcf. Low density generally indicates sand layers, voids or too much air, ultimately leading to low strength.
